# FIRE EQUIPMENT ALERT BLM-2010-02

The National Fire Equipment Program (NFEP) is issuing an equipment alert which may affect vehicles in your fleet. Recently two BLM 662 Light Engines experienced failures of the rear wheel assemblies. If F150, F250, F350, F450, F550 are part of your fleet ensure that an immediate visual inspection of the vehicle rim, hub, and tire assembly takes place. This alert is being issued as a preventative measure for all Fords. The NFEP is investigating the specific cause of this failure and further guidance will follow this initial alert.

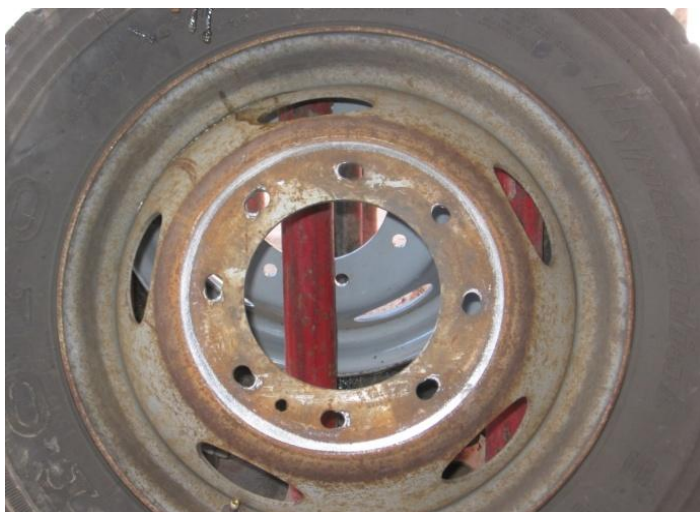
Figure 1: Notice elongated lug holes

- Remove each tire and wheel assembly. Inspect the rim for elongation of lug holes. (Figure 1)
- Inspect overall appearance of the rim. Look for signs of slipping e.g., shiny spots on the back and front side of rim, cracks or unusual wear.

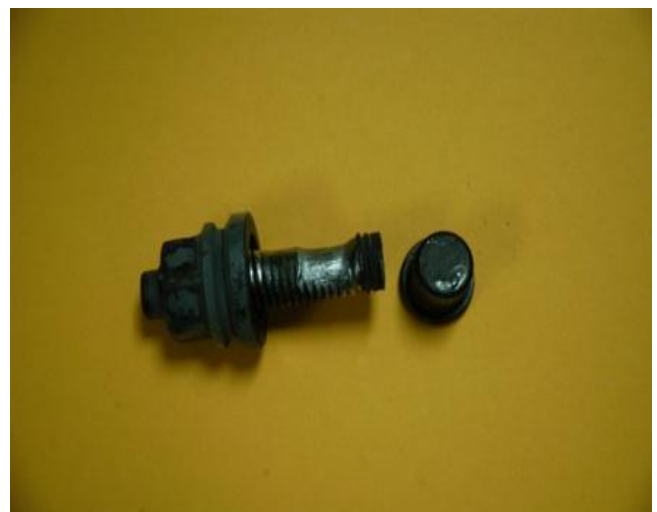
Figure 2: Extreme wear on lug

- Inspect the lugs and lug nuts for unusual wear. Ensure you look at the flat washer portion of the lug nut for shine and signs of slipping. (Figure 2 and Figure 3).

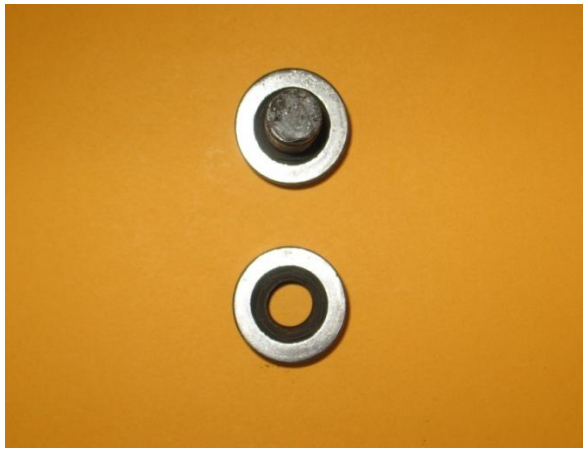
Figure 3: Lug Nuts surface is shined

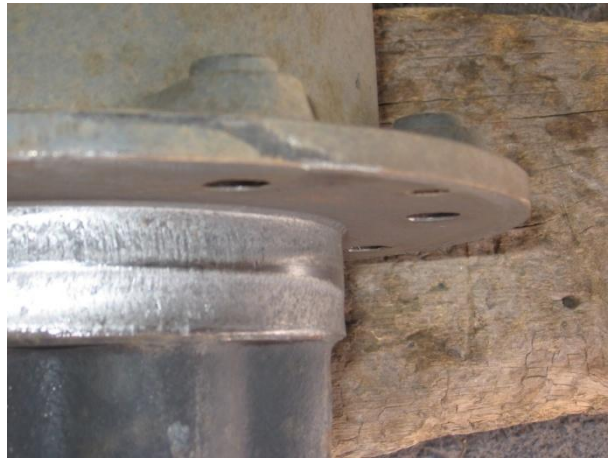
Figure 4: Shine on hub from wheel wear

- Inspect the hub. Look for signs of wheel wear on the actual hub. (Figure 4).
- Ensure that wheels and lugs are cleaned of dust and debris before installing wheel back on vehicle. Foreign debris and a dirty surface can cause a space which can cause the lugs to loosen.
